# Mount St. Helens Ecosystem Restoration General Reevaluation Study Reconnaissance Report

Sediment Retention Structure on the North Fork Toutle River

July 2007

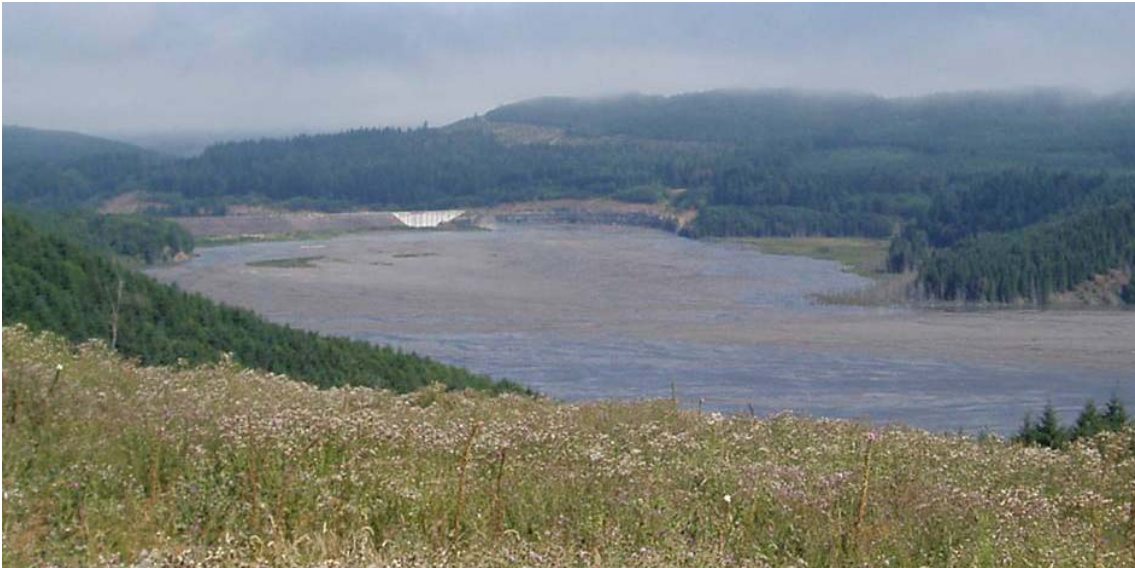
*Figure 1. Sediment Plain Upstream of SRS (seen in the distance)*

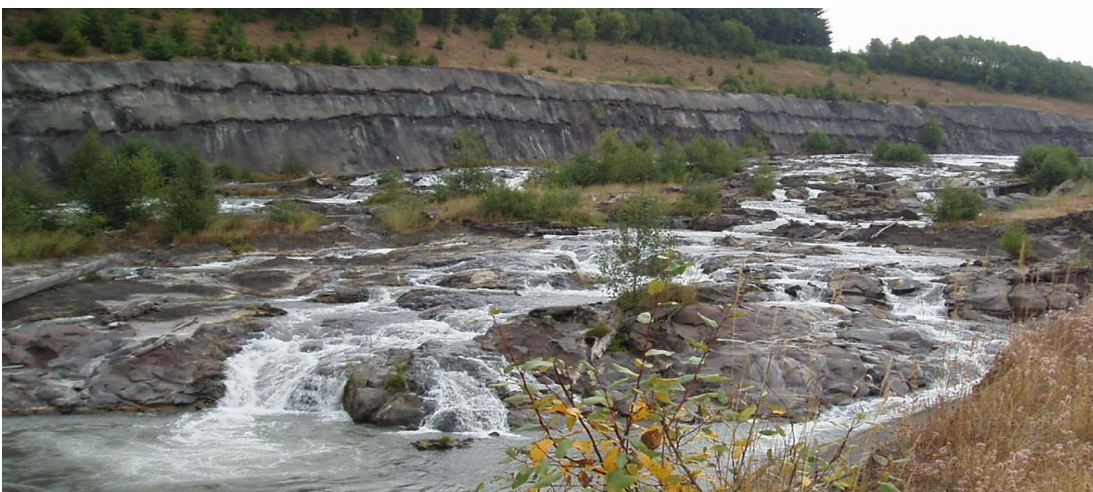
The SRS spillway is a 2,200-foot long, 400-foot wide, unlined, rough-bed channel with a 7% gradient (Figure 2). High flows in 1996 damaged the spillway and caused a 6-foot vertical drop (falls) at the downstream end of the spillway. In response to the damage, the Corps constructed a weir 1,000 feet downstream of the crest to prevent down-cutting, and made minor structural repairs to the spillway. Currently, water flows through a series of high-velocity cascades and depending on flow levels, over shallow sheet-flow areas before ending in the 6-foot vertical drop at the spillway's downstream end. The water continues downstream through a combination of riffles, runs, and cascades and over a concrete velocity barrier at the fish collection facility (FCF) before merging with the Green River.

*Figure 2. Middle Section of the Spillway on the North End of SRS at Late Summer Baseflow*

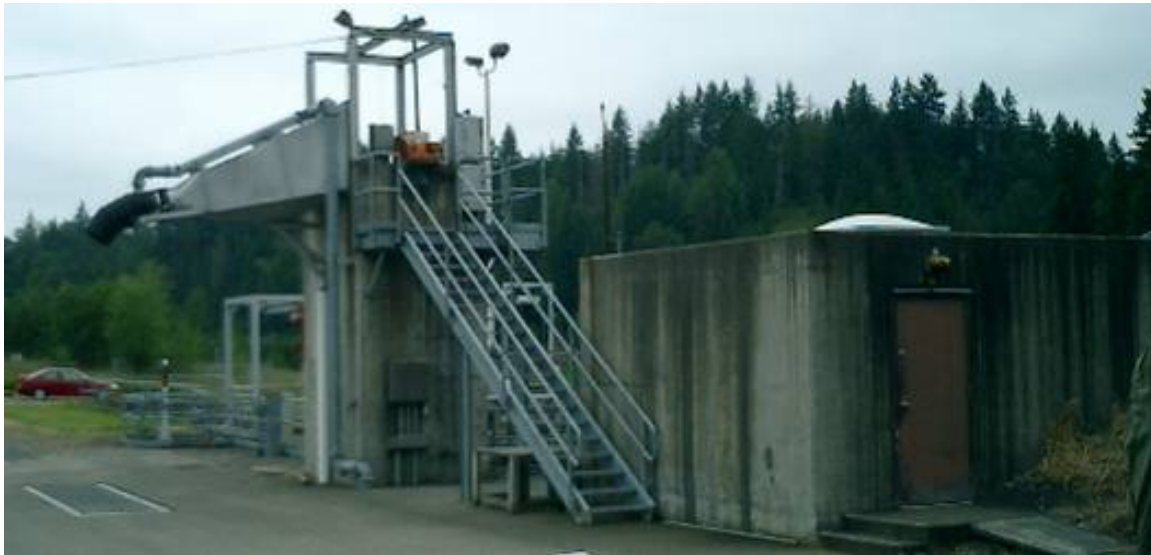
As mitigation for the SRS, a trap-and-haul FCF was funded and constructed by the Corps on the North Fork Toutle River 1.3 miles downstream from the SRS to facilitate fish passage (Figure 3). The FCF was turned over to the State of Washington to operate and maintain. Adult steelhead trout (*Oncorhynchus mykiss*) and coho salmon (*Oncorhynchus kisutch*), both threatened species under the ESA, are collected at the FCF. Fish are collected by diverting a portion of the river above the FCF into a fish ladder. Fish are attracted by this flow into the ladder and move up into a collection pond. Fish are then moved into transport tanks on trucks and taken to two upstream release locations (Hoffstadt and Alder creeks). Transported fish are released randomly in each stream without knowledge of their stream of origin. Large sediment volumes in the North Fork Toutle River have contributed and continue to contribute to FCF operational problems.

Figure 3. Fish Collection Facility Downstream from the SRS

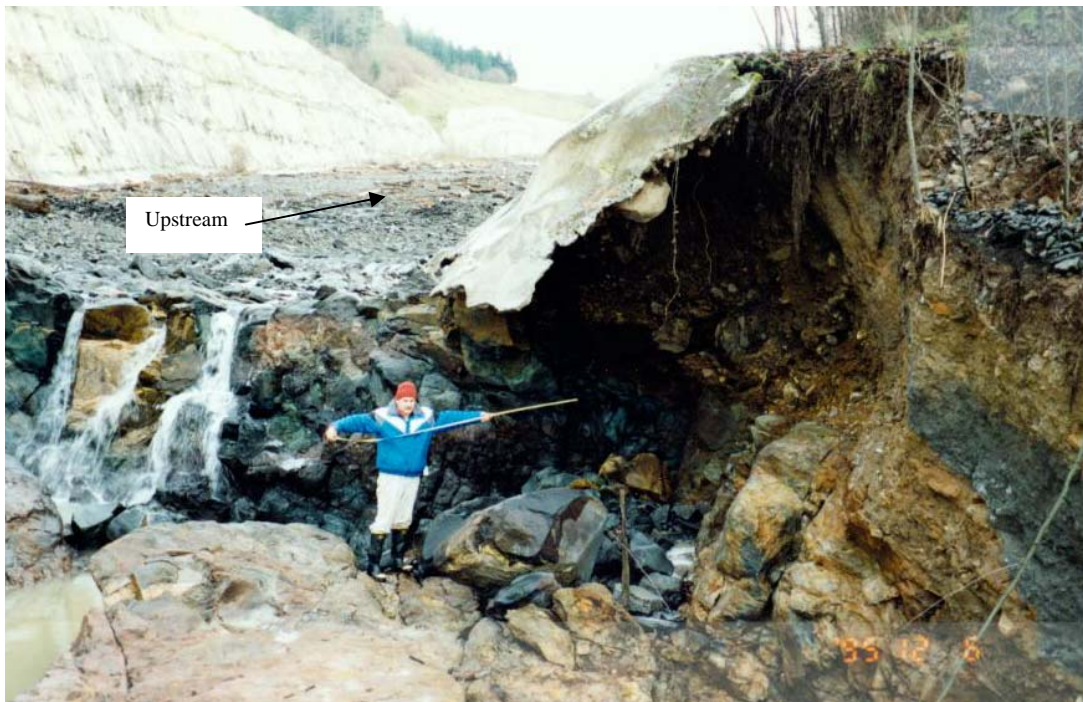
*Figure 12. 1995 Erosion Creating the Falls*

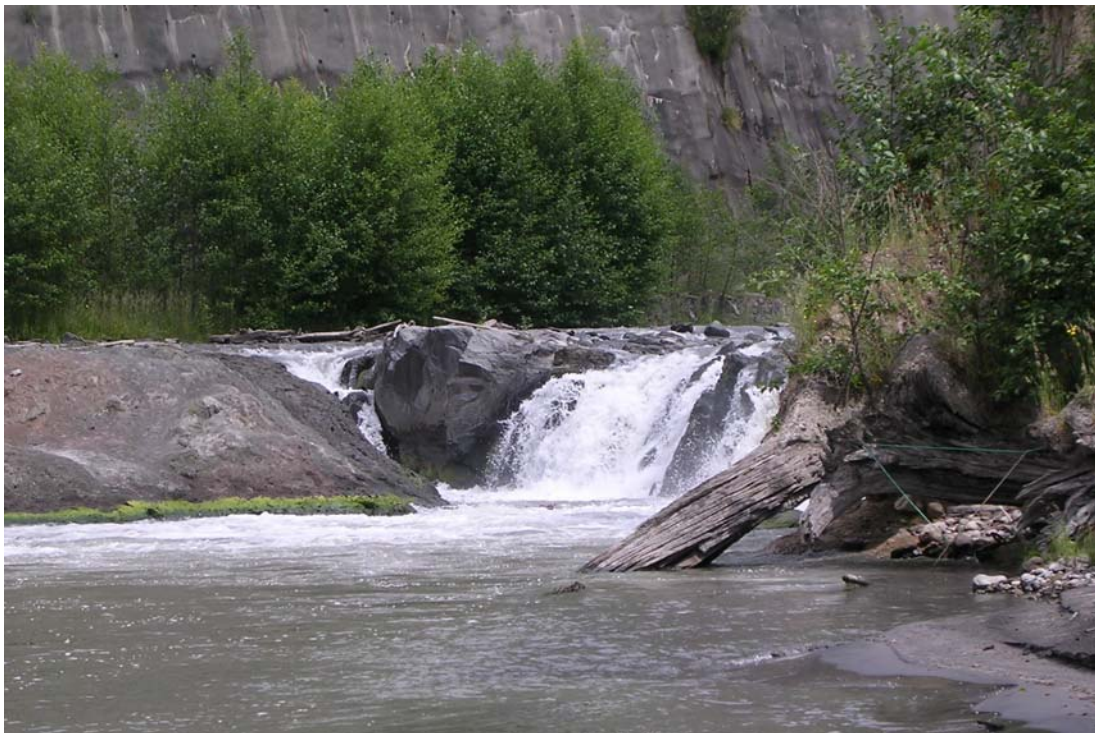
*Figure 13. The Falls Today*

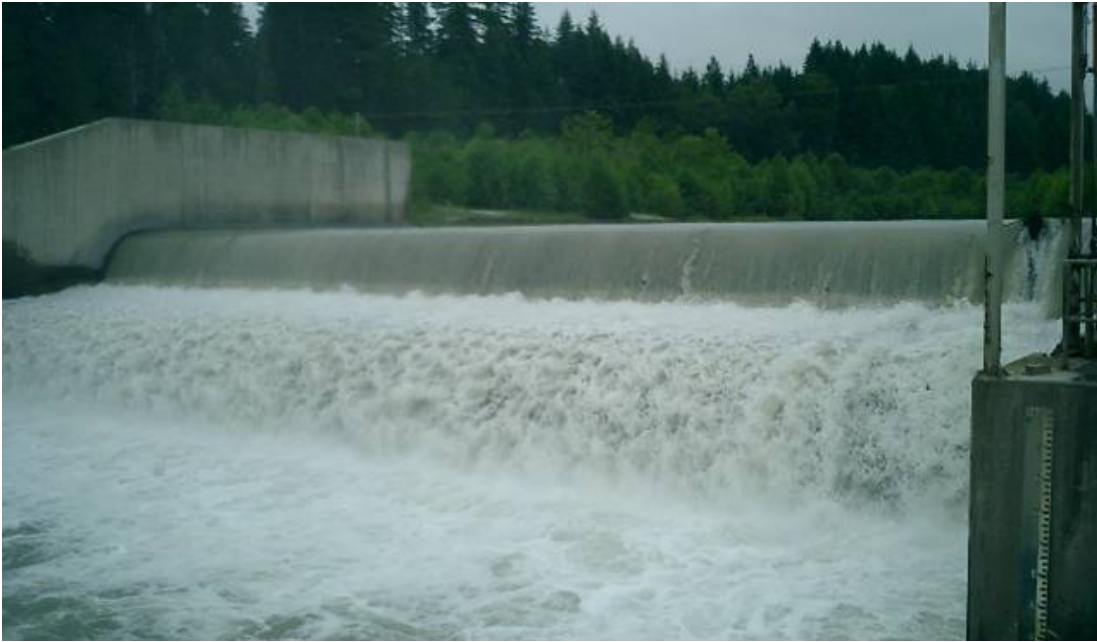
**Remove FCF Fish/Velocity Barrier.** If the SRS spillway improvements lead to desirable volitional fish passage, the next step could be to modify the FCF itself to allow for volitional passage. Volitional passage at the FCF is prevented by a concrete fish/velocity barrier (Figure 14). The barrier forms a two-tiered falls about 25 to 30 feet in height. To allow for volitional fish passage, the concrete structure would be removed and the upstream river channel would be graded to produce a navigable slope and channel for fish. The total estimated cost for this measure is \$1 million.

Figure 14. FCF Fish/Velocity Barrier
